Evolution of Dam 1533 and
the Breach in Turtle Creek
1937-2018

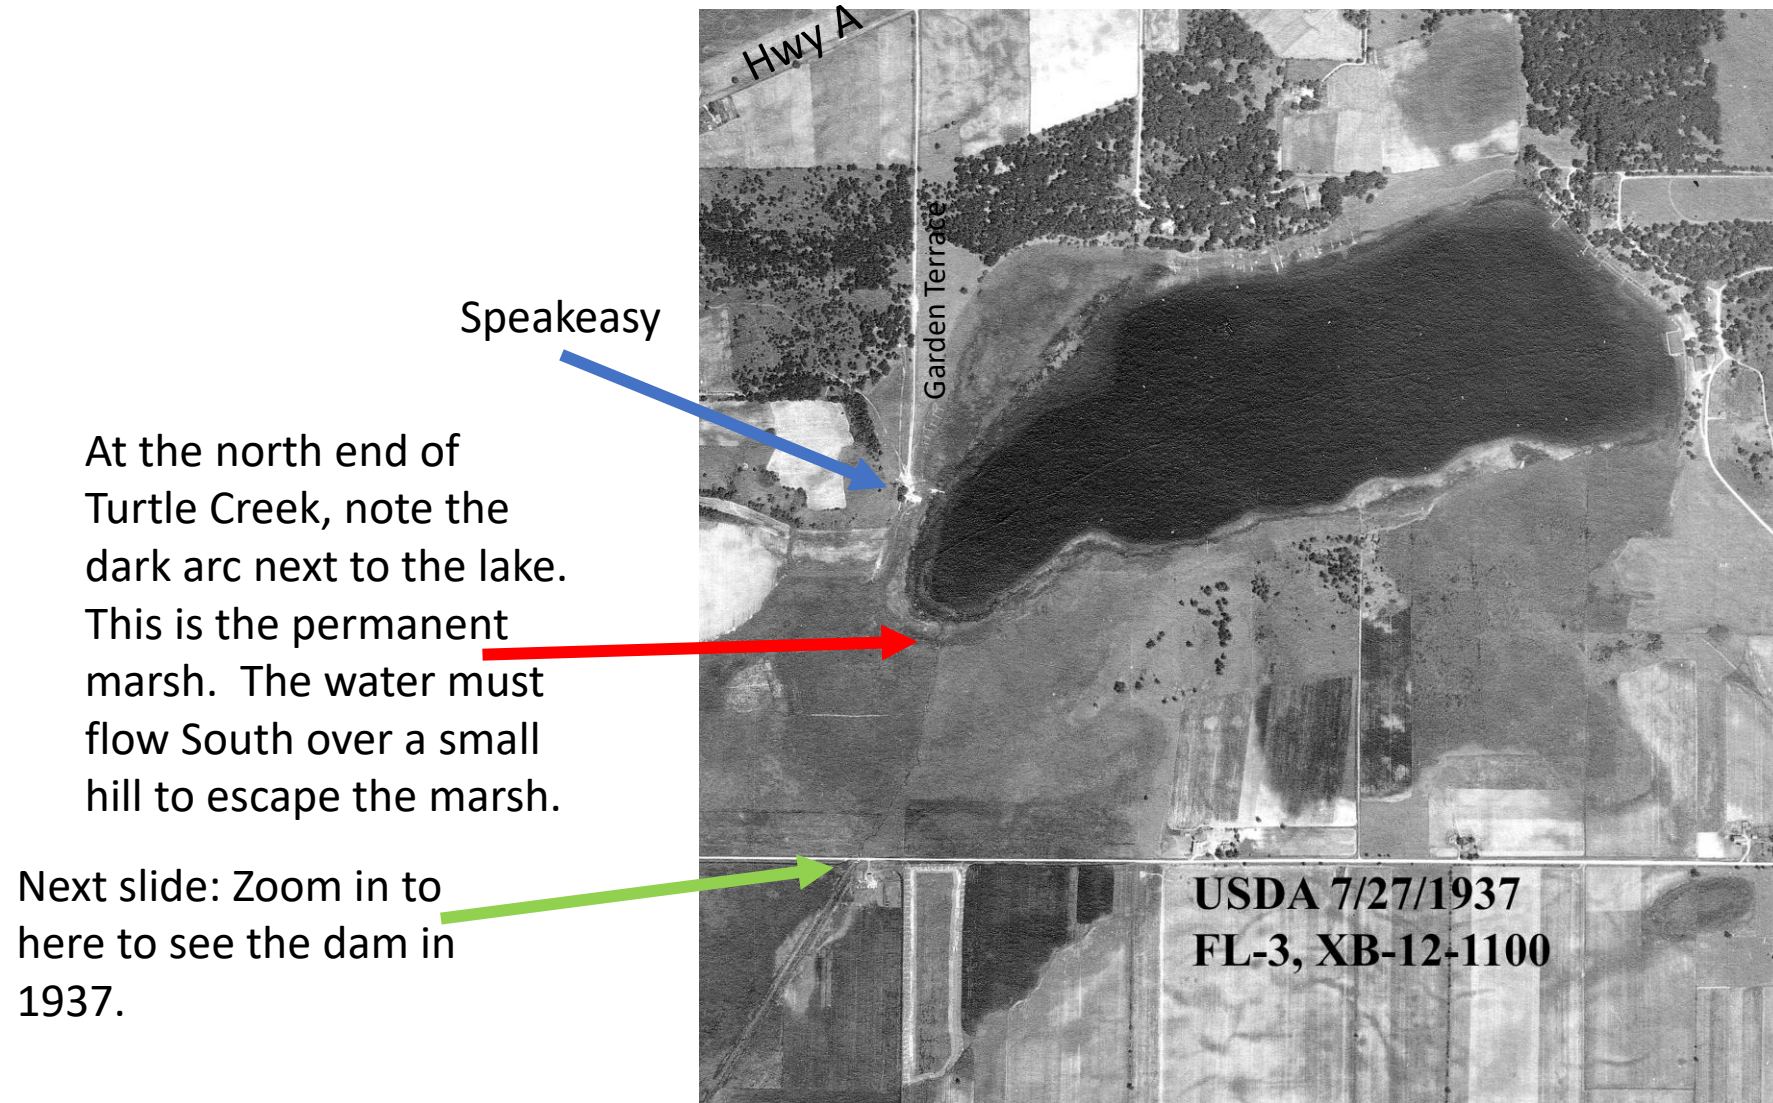
Turtle Lake in 1937. Fewer trees and houses, no duck pond, no breach in the creek.

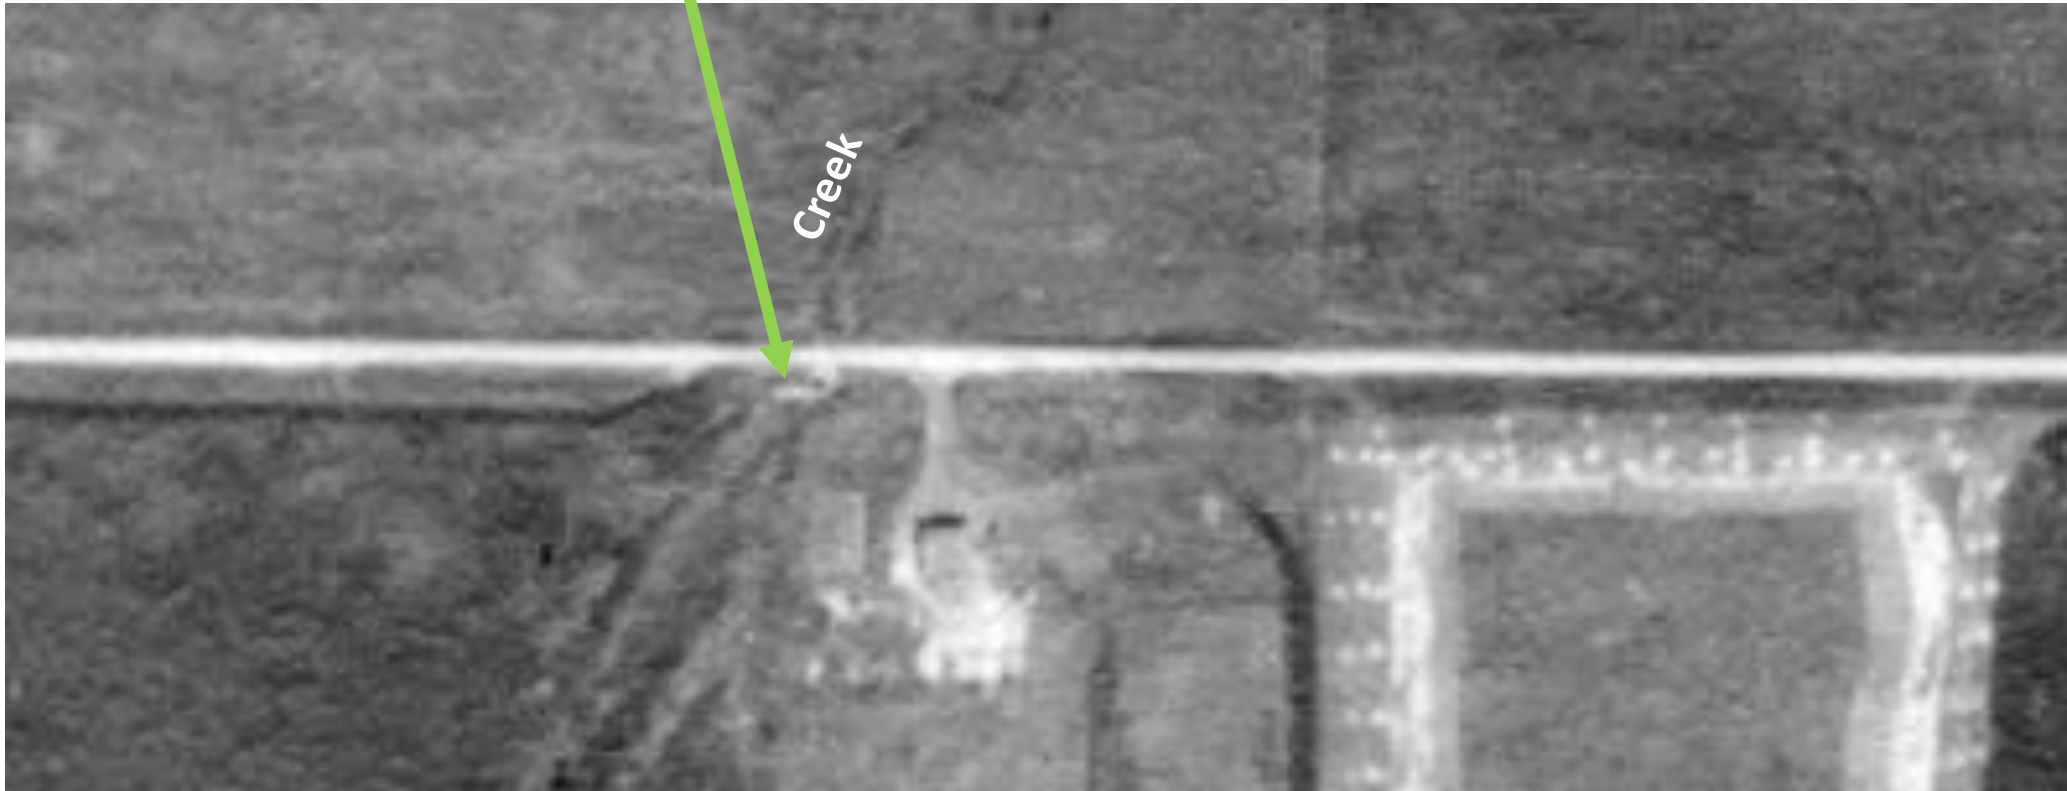
1937: Dam 1533 is south of Turtle Lake Road.
The road is white because it is not paved.

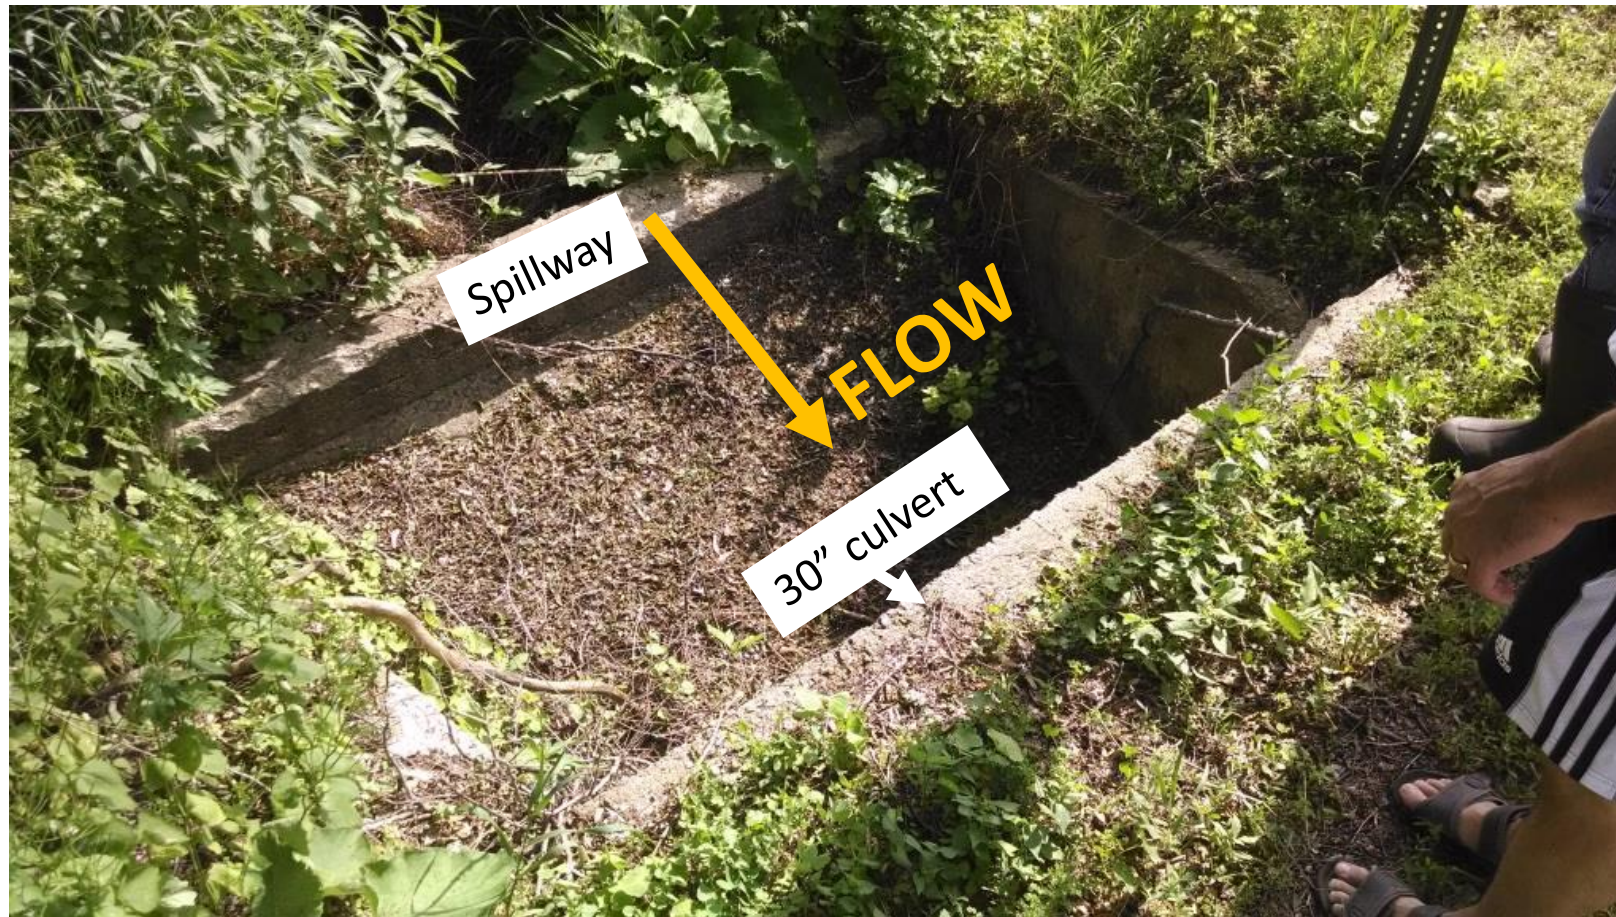
9 ft. wide concrete dam North of the Road

Looking Northeast. First used spring 1942. Photo by AECOM 6/7/14.

Before the breach in the creek, water used to sometimes flow down the creek, over the spillway, and under the road through the 30 inch culvert.

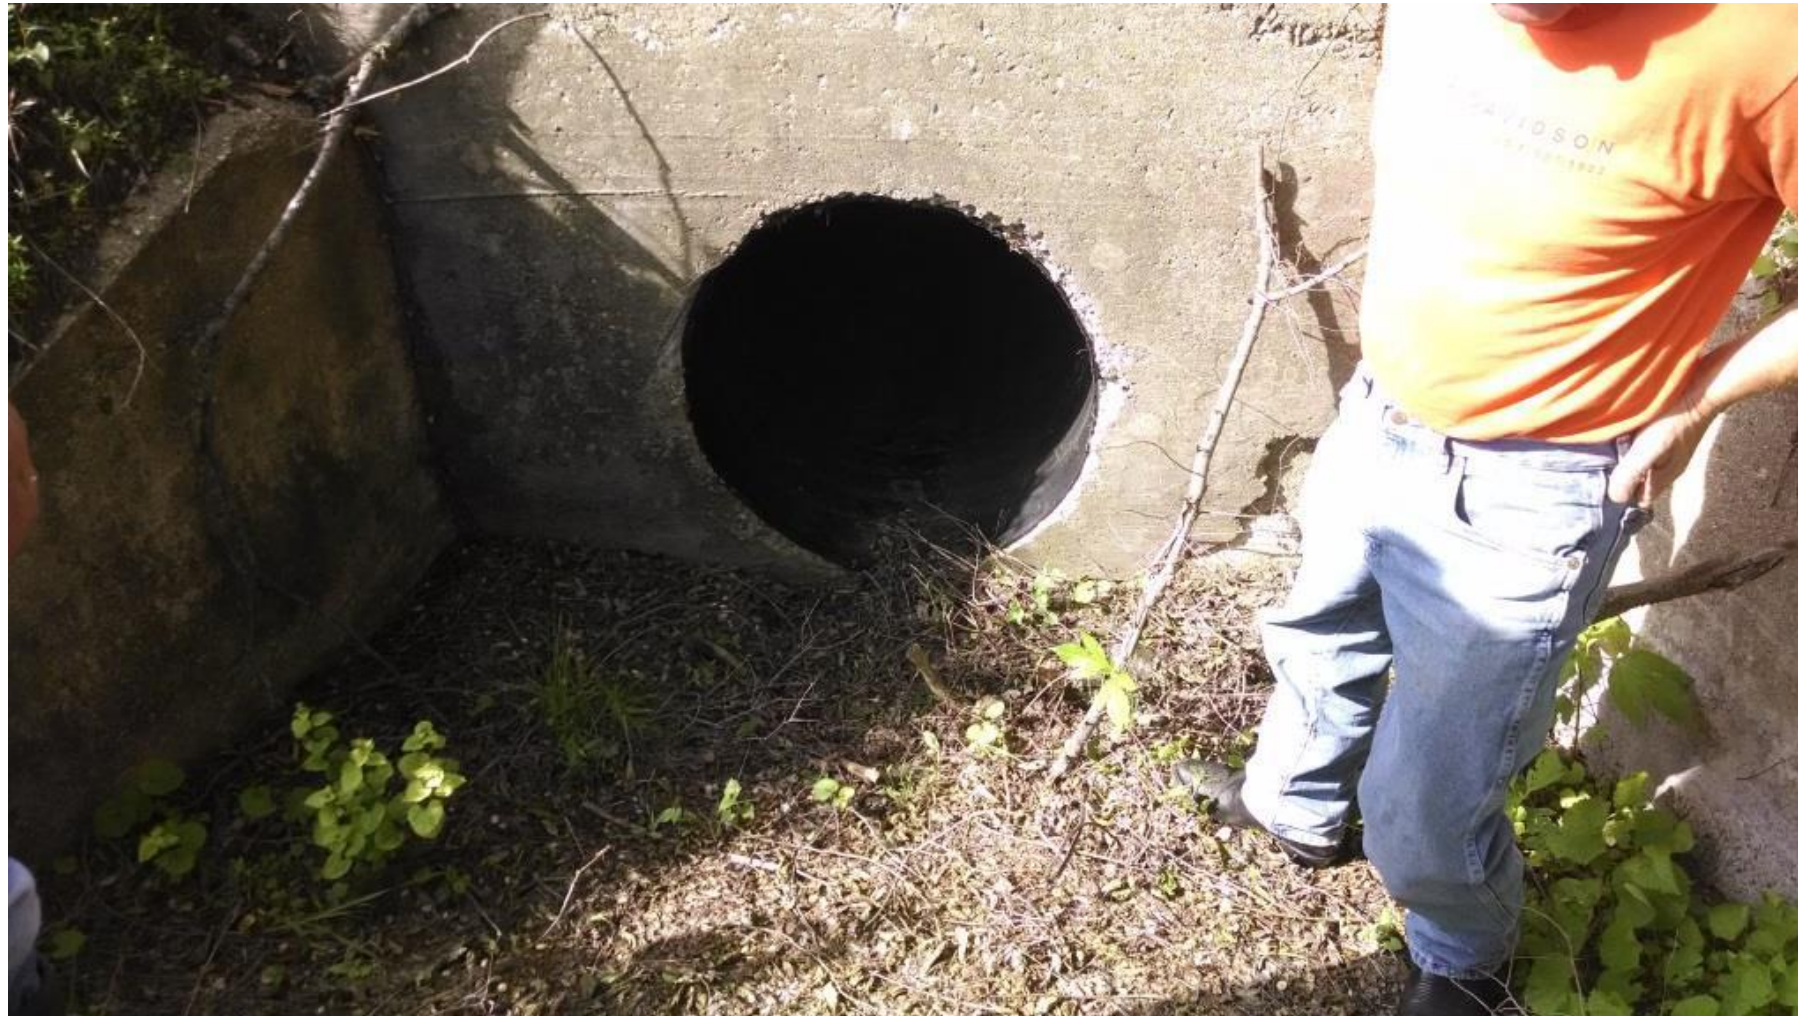
Looking Southwest at the dry 30" culvert inlet

Water over the spillway fills this “drop box” or “drop inlet”. AECOM 6/7/14.

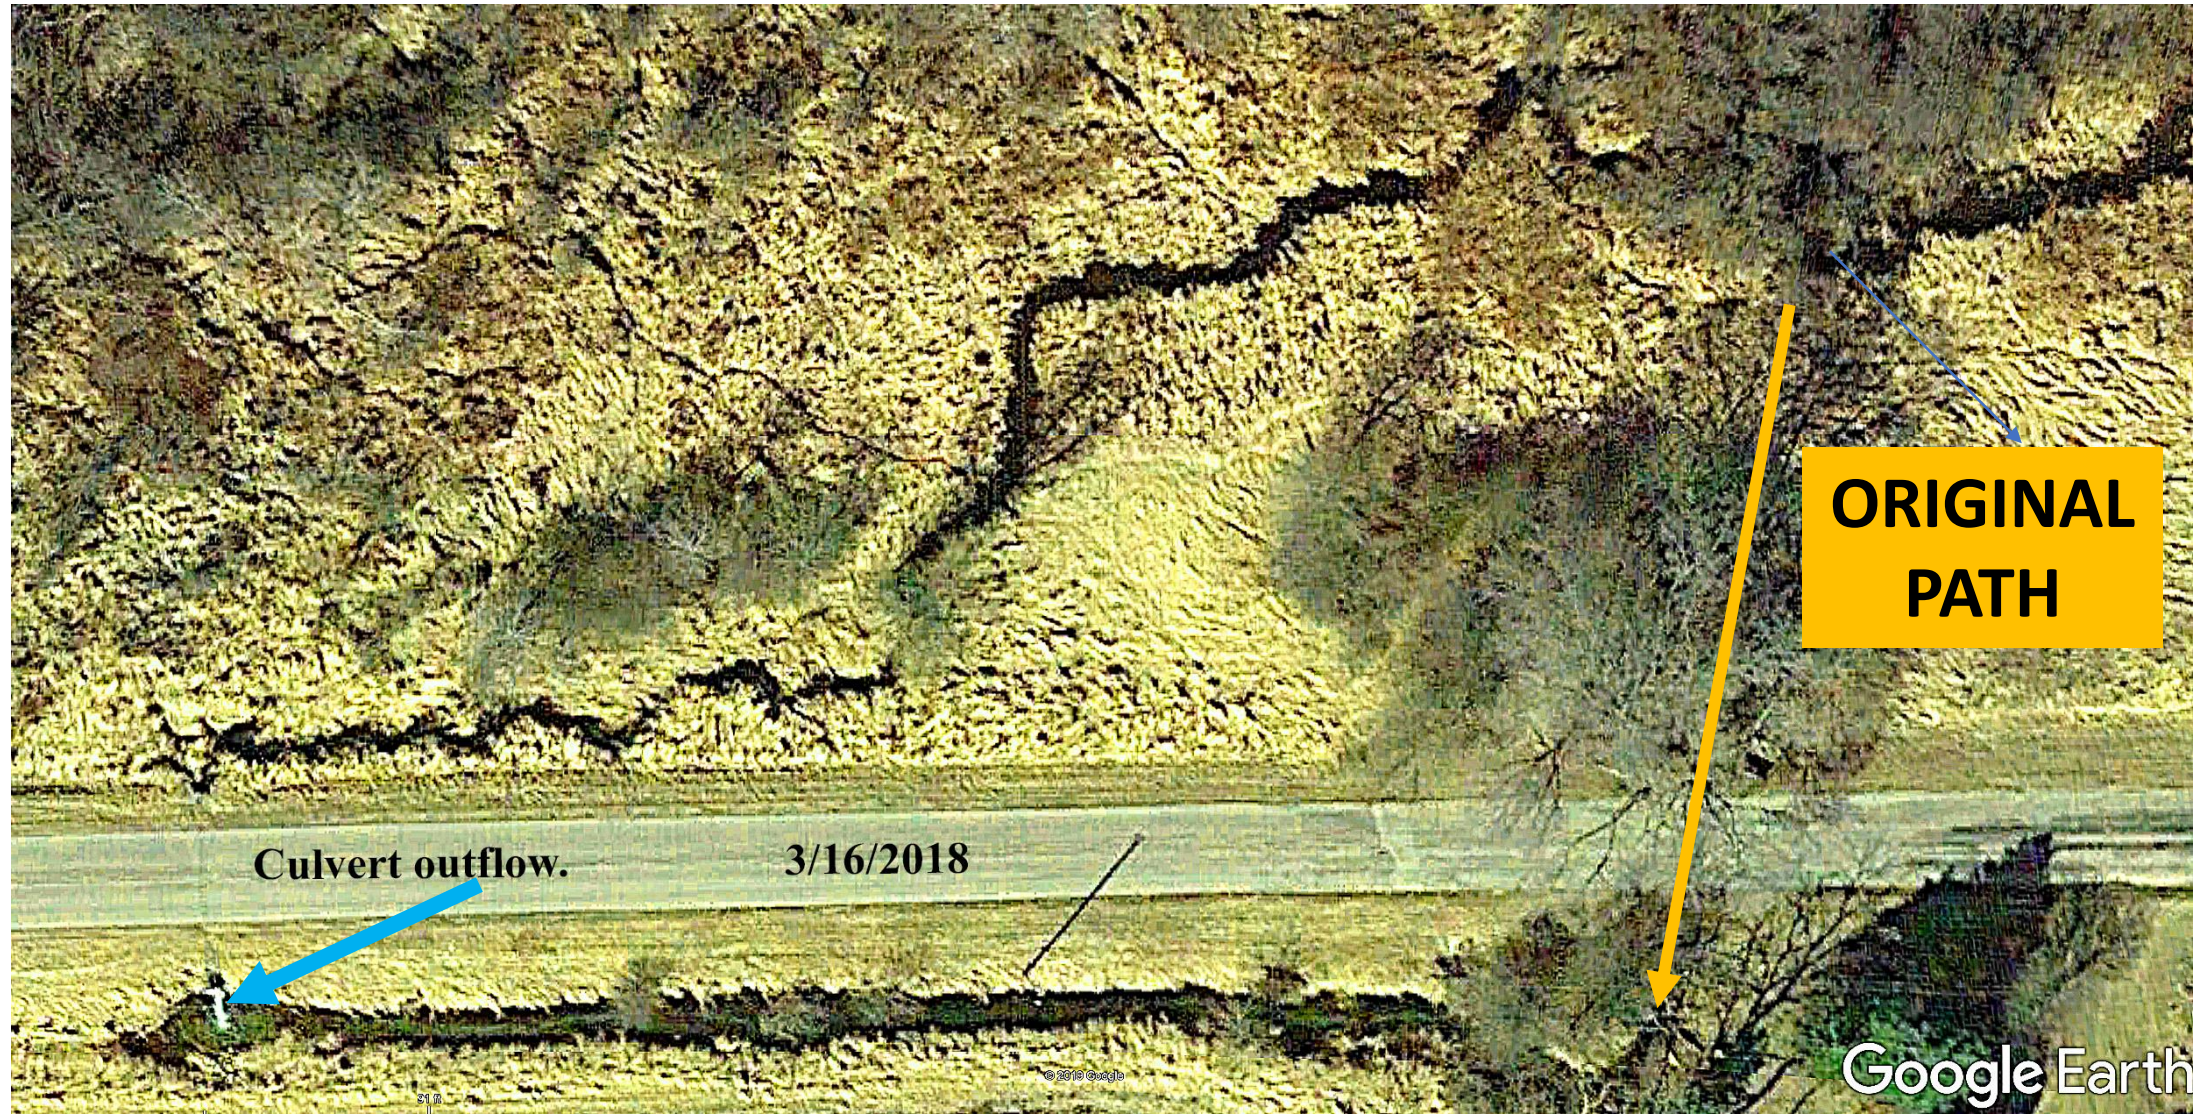
BREACH FULLY FORMED. 3/16/2018.

All the surfaces shown here are well below the natural dam near the lake. All the water shown was way upstream “over the dam”.
