# Turtle Lake ups and downs: 2008-2018

*Turtle Lake's Surface Stays Well **Above** the concrete Dam, Except During an Extreme Drought.  
Why?*

By George M. Lawrence, PhD, [With much help](#). Version of 2/19/2020.

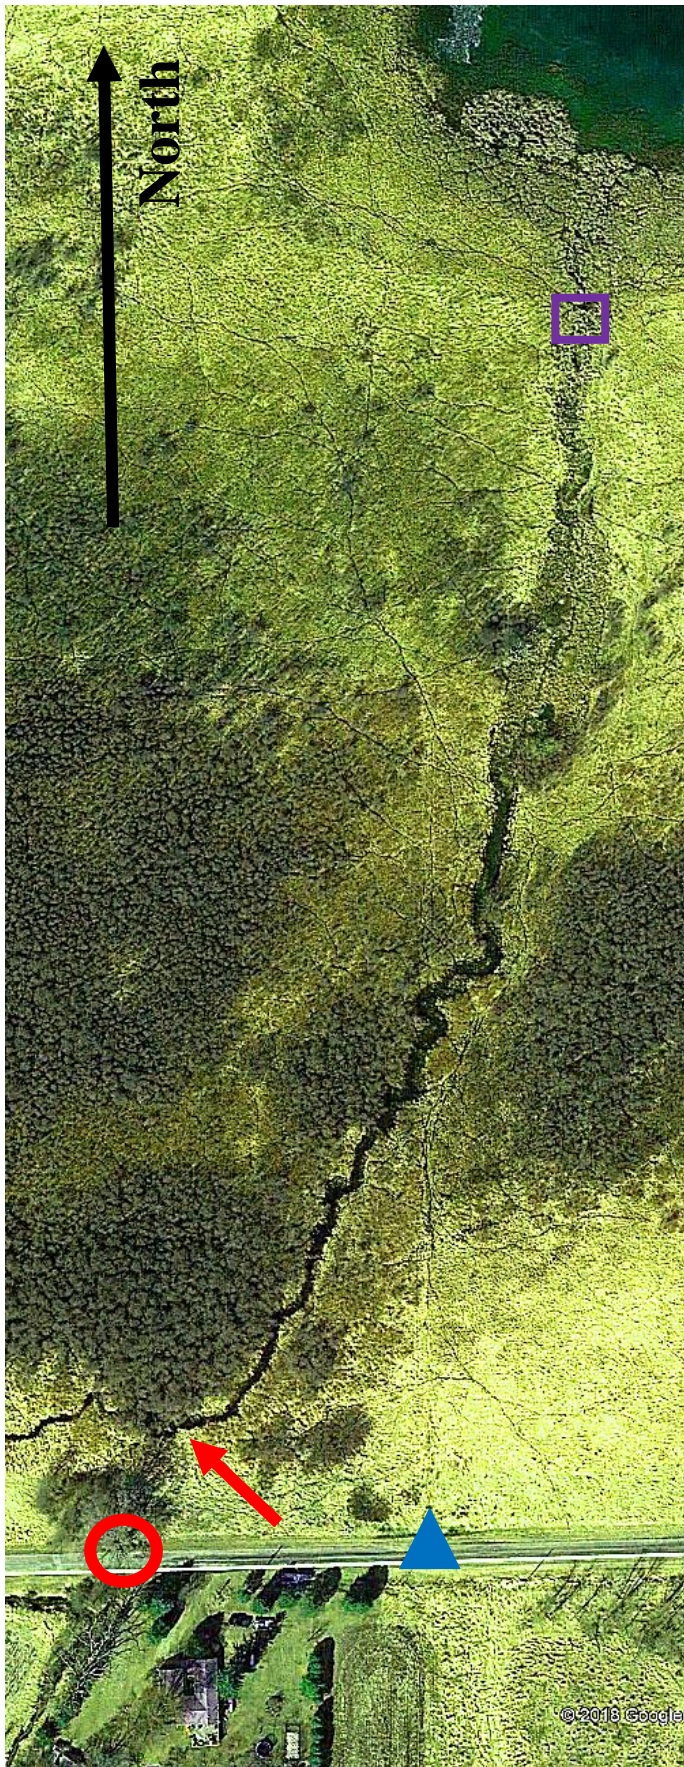
Fig. 1. Outflow from the Turtle Lake: The marsh, the natural dam, and the creek.

water flows out of the lake through the marsh, then ¼ mile southward down Turtle Creek, dropping as much as 5.3 ft to get under Turtle Lake Road through culverts. The marsh is the darker region arcing just south of the lake.

When water leaves the lake, it has to get through the marsh and then over a **high point** (natural dam) **in the creek**. The **purple square** shows the **officially** mapped position of WDNR dam #1533, “Dam Turtle Lake”. [This natural dam defines the levels of Turtle Lake](#). From 1936 to 2002, the [WDNR](#)’s definition of Turtle Lake’s dam changed twice from a 1930s 20-ft wide concrete dam **South of Turtle Creek Road**; to the 9-ft wide 1942 concrete dam just north of the road; to the natural dam near the lake. This earthen natural dam was “always” there, but not always recognized and it became the **only** dam when the breach in the creek occurred. Natural dam #1533 **saves** Turtle Lake from draining through the much lower culverts at the road. **Protect our natural dam!**

In late summers, denser marsh and creek vegetation also resists the outflow, raising the lake further. In winters, ice resists the outflow. Note the bush near the lower right corner of the purple square. The bush indicates high ground and we see it in aerial photos at least back to 2005 ([Fig. 12, pg. 12](#)).

The red arrow just above the road shows the infamous breach in the creek which diverted the flow to very low culverts and dried the concrete dam. The breach has caused much anguish.

The 1942 historic concrete dam at the road hides (mostly) dry in the red circle. Later we argue that this dam’s elevation is near 899.1 feet above sea level—on a scale consistent with our elevation reference. A 1965 official survey of the concrete dam allowed a 2” stoplog atop the dam. However, a 1979 inspection by the WDNR caught a 7” stoplog there—a No-No because it floods farmland and the road.

The blue triangle locates the official survey marker (center of section 14) closest to the concrete dam. It locates local property and section lines—and is an elevation standard.

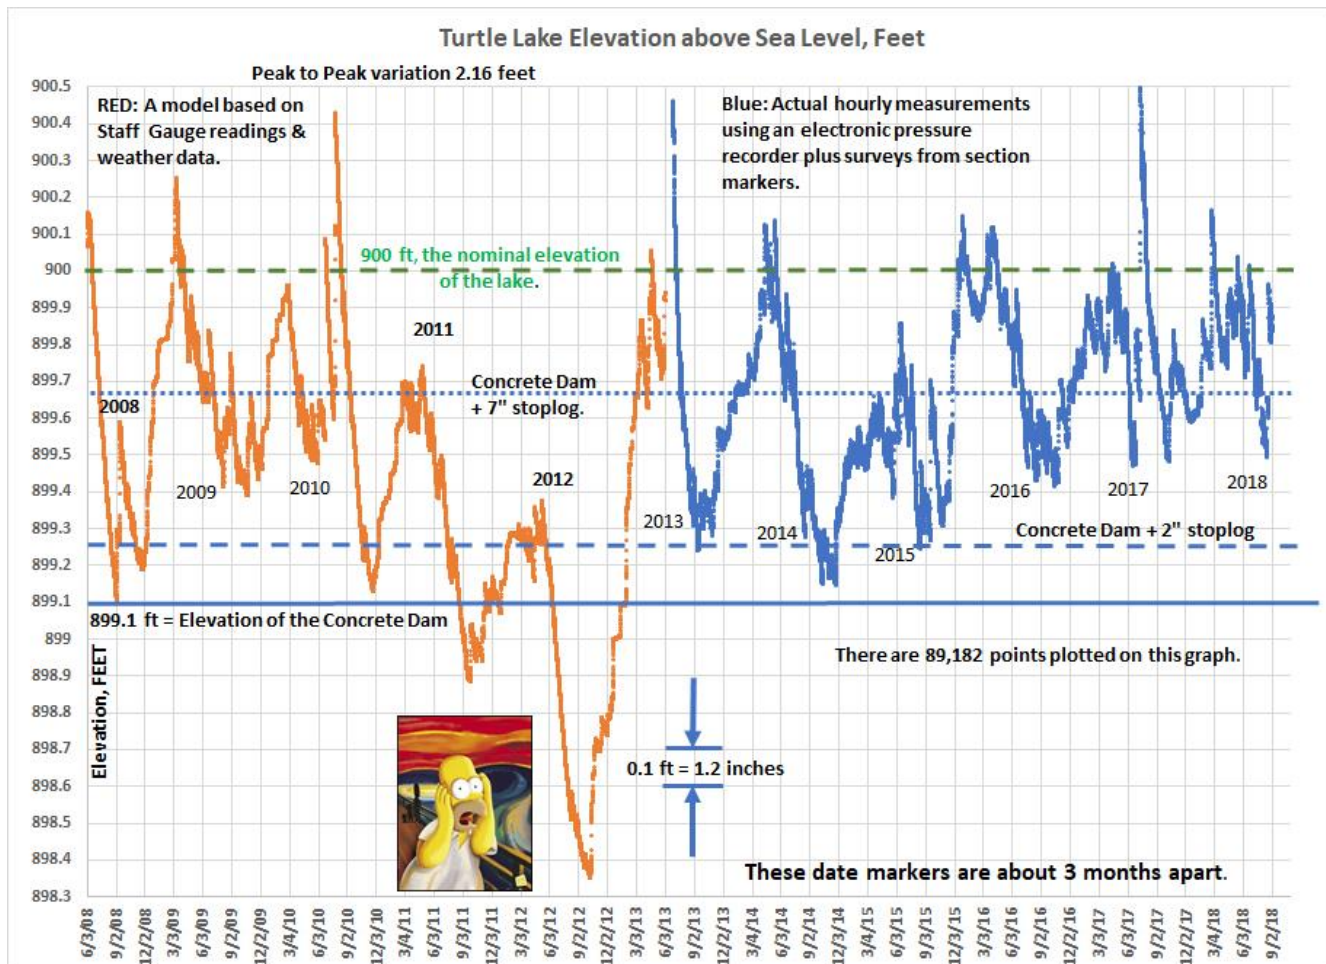
Fig. 2. 89,182 Hourly Elevations June 2008 to September 2018.

This graph plots ten years of elevations above sea level. Elevations in feet are plotted vs. calendar date. We'll explain on pg. 7 how we measured these elevations. Note the drought in 2011 & 2012. Note the heavy horizontal lines drawn for elevation references. Lowest is the concrete dam shown at 899.1 ft. The next (dashed) line is a legal 2" stoplog atop the concrete dam and it still lies (most of the time) below the natural water levels. The dam plus illegal 7" stoplog (dotted) hits the levels about in the middle, and 900 feet is shown because that is the standard elevation shown on maps. There were only three times in these 10 years that the elevation rose very briefly **above** 900.4 ft. The level then comes down quickly because 900.4 ft is high enough to find paths around the natural dam #1533. That is, it has lots of wetland area to flow over. Above 900.4 ft, some lakefront properties begin to show shore-line flooding—but not for long. (A recent exception is the summer of 2019—it rained a **lot**.)

I revealed the main conclusion in the subtitle. The lake surface naturally lies **most times** above the 1942 concrete dam—this concrete dam itself would do almost no good in raising the lake. However, an illegal 7-inch stoplog atop the concrete dam **would** do **some** good—and some harm. Significantly raising the lake would require a dam at least 7 inches higher than the concrete dam.

Ironically, even though the drought in 2012 caused the lake to go 9 inches below the concrete dam, the dam would not have helped because the creek dried up. No water in the creek, no water over the concrete dam. There was no outflow from the lake—only evaporation in the hot, dry air. Note that it took 3 months to drop to the lowest point—during three months of the "[extreme drought of 2012](#)". During an extreme drought, the level will drop below **any** working dam.

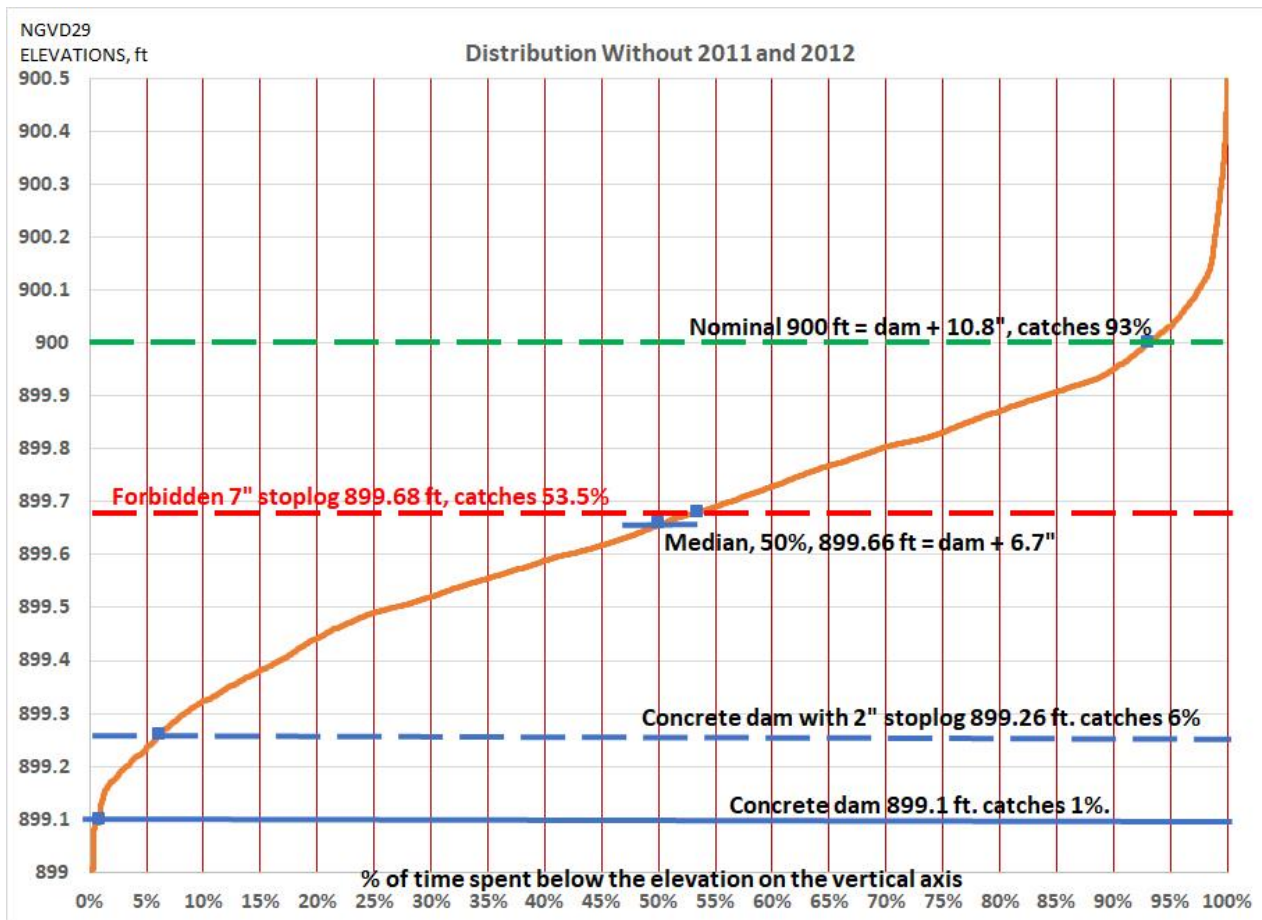
Note: Elevations **over** 900.4 ft. flood yards, **under** 899.3 ft. make some shores shallow and muddy. The lake behaves fairly well, except for drought years. Non-drought, minimum to maximum is 1.5 ft, and 90% of the time it spreads only 1 ft. Let's read the graph where the horizontal elevation lines cross the red-orange distribution curve: The concrete dam alone would only raise the lake 1% of the time. The dam plus the 2" stoplog helps 6% of the time. A dam at 899.66 ft would raise the lake 50% of the time, and using the illegal 7" stoplog at the road would help 53.5% of the time. A dam at 900 ft elevation (10.8" higher than the concrete dam) is the elevation of Turtle Lake on maps and would raise the lake 93.1% of the time.

One foot of variation still affects fish and vegetation populations. Drought years are frustrating. The concrete dam is at least 7 inches too low. The 7" stoplog at the concrete dam really raises the lake ½ of the time, but: We cannot, may not, should not, use a **7" stoplog** at the concrete dam because:

- There is a major breach in the creek, usually keeping the dam dry.
- 7 inches would eventually destroy any fix that had been made to the breach.
- 7 inches is forbidden by the WDNR so as to protect the road and adjacent property.
- 7 inches would threaten the road with flooding.
- 7 inches floods private land whenever water is flowing over such a "dam with 7 inch stoplog" and especially during the spring runoff because the level might rise ½ foot above the spillway for this 9 ft wide dam.

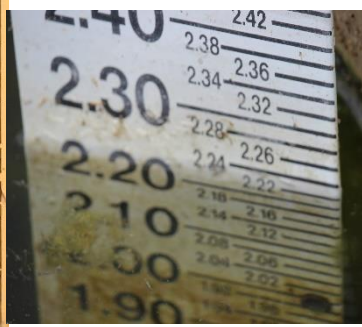
← **Fig. 5. Ruler in the lake (Staff gauge) reading 2.22 feet.** We then add the elevation of the zero point of the gauge to get sea level elevations.

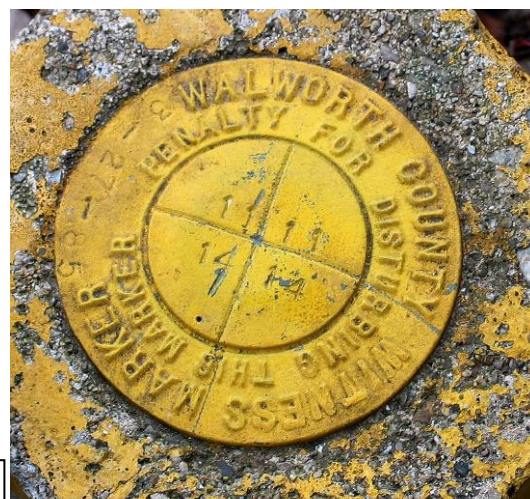
↑ **Fig. 6. Marker at the end of Garden Terrace Road.** It reads: "WALWORTH COUNTY WITNESS MARKER 3/27/85 Penalty for Disturbing this Marker." The cross in the center marks the east west line between sections 11 and 14 and the north-south center line of both. The 4" metal disk is set into a concrete block. Officially, its elevation is 919.902 ft to the NGVD29 datum.

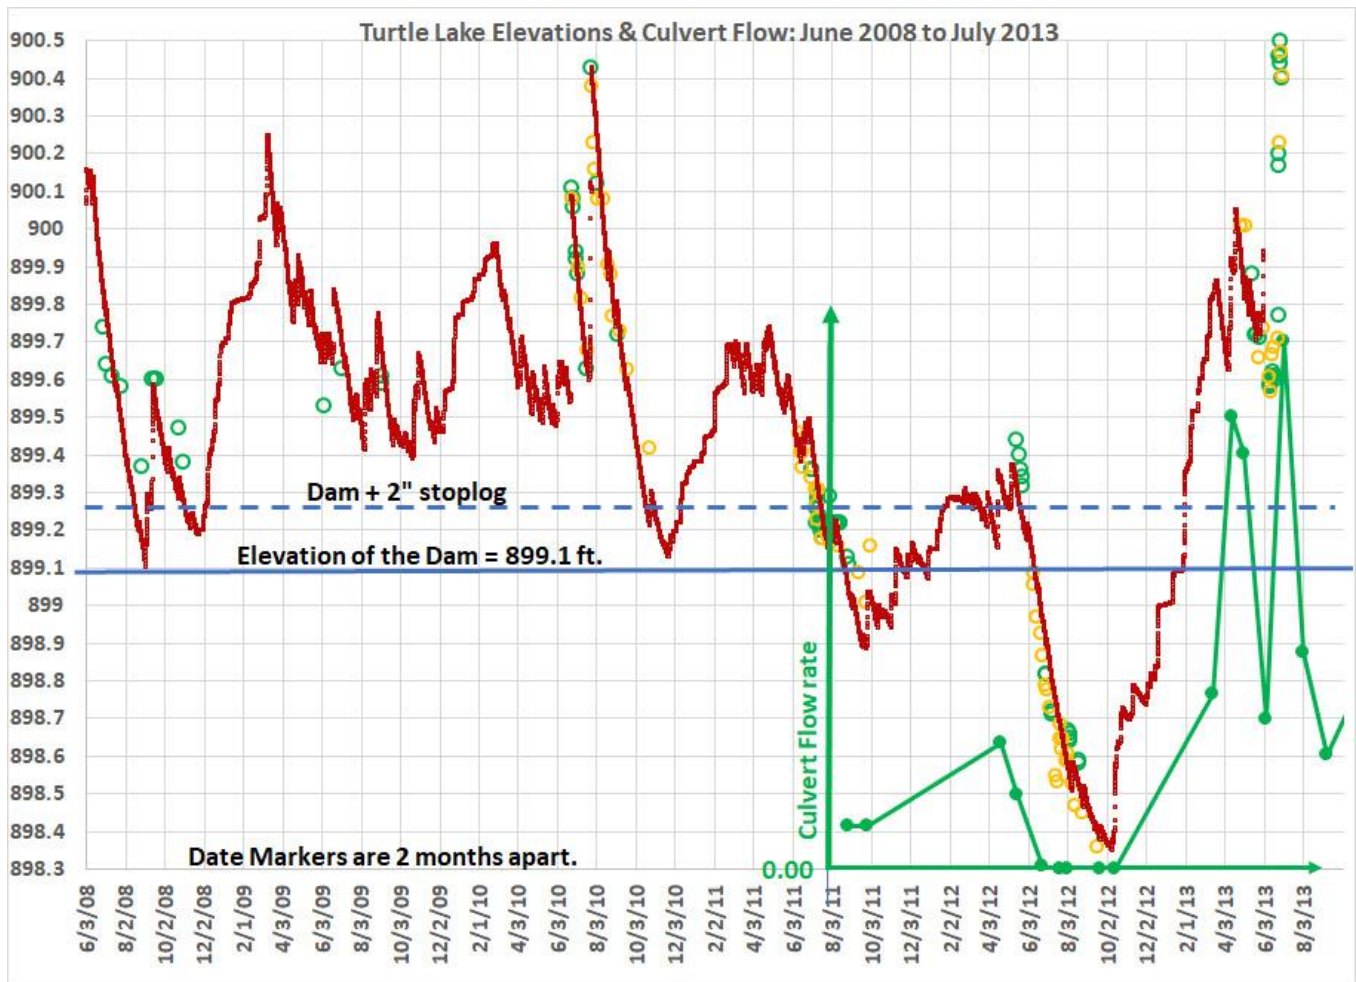
**Fig. 7. Lake Elevations & Culvert flow: June 28, 2008 to June 26, 2013—1<sup>st</sup> five years.** Green circles are *Auer* staff gauge measurements; gold-orange circles are *Baas* measurements. Vertical grid lines (showing time) are about 2 months apart; the horizontal grid lines (showing elevation) are 0.1 feet apart. The red curve is an hourly mathematical model based on regional weather data. It fits the staff gauge data as best it can. The green inset shows culvert flow. This figure and Fig. 8 plot a total of 741 staff gauge measurements.

In Fig. 7, you will again notice the painful drought that started in 2011 and became severe in 2012.

The drought in both years caught our attention and motivated lots more staff gauge measurements. We then quit measuring for the winter and found the elevations restored by early summer 2013. Note that the lake lies **above** the concrete dam (except for drought years) because the natural dam is higher. The **allowed** 2" stoplog would help only a tiny bit.

In Fig. 7, the green inset graph at bottom right shows the relative flow through the culverts at the road, as measured by Pat Carroll. The lake dropped well below dam #1533 and the creek and culverts dried up completely (zero flow) in the summer of 2012. The lake continued to go down because of evaporation—and/or ground leakage. With a dry creek, a dam cannot help raise the lake.

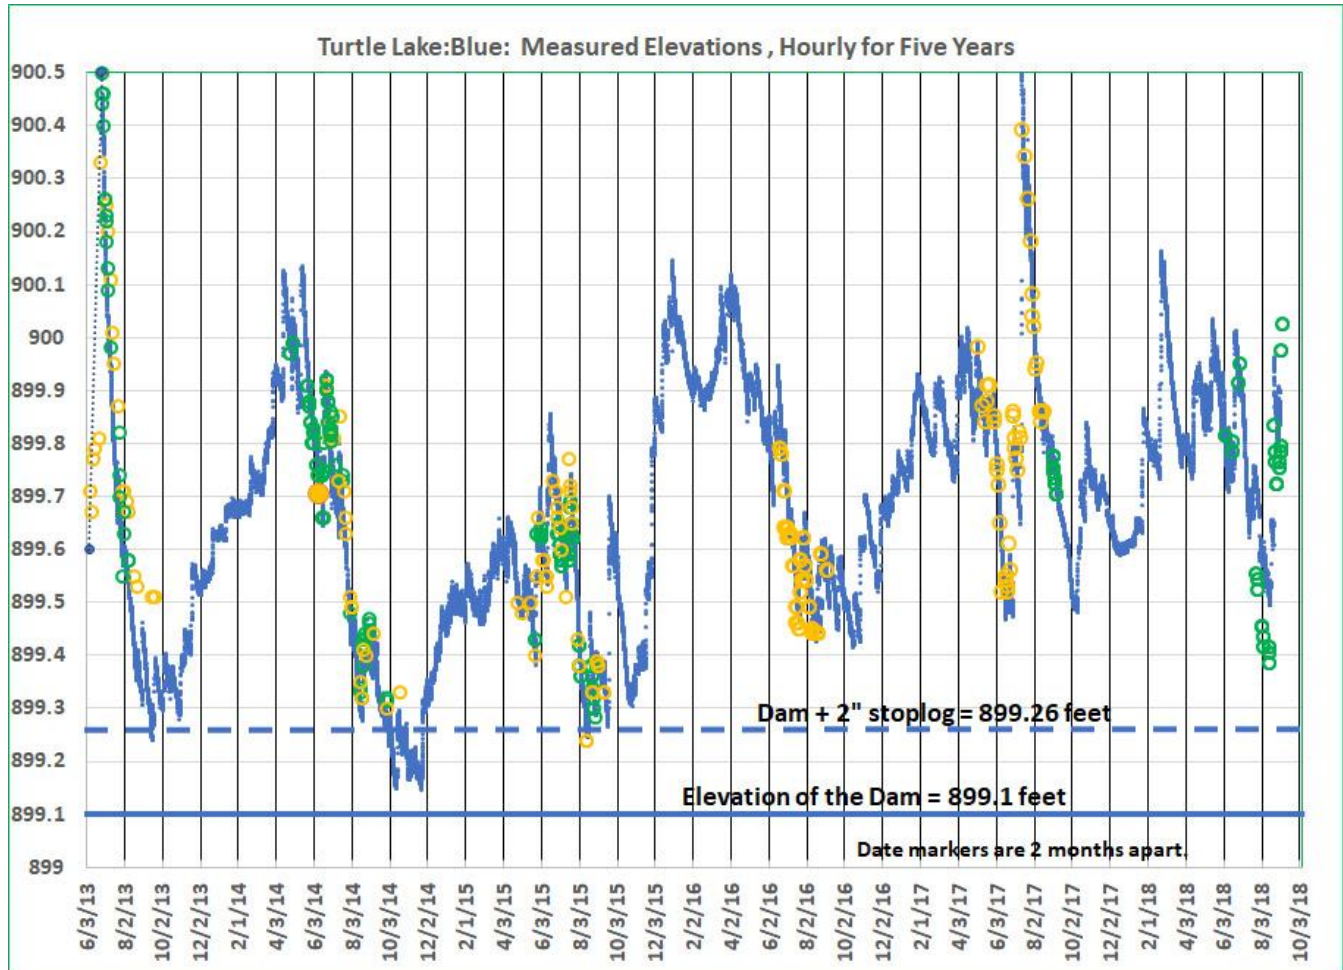
**Fig. 8. Automatic measurements of the lake elevations from 6/7/13 to 9/4/18—next five years.** The vertical range is less than in drought years (see Fig. 7). Mostly, the levels are between 899.2 and 900.1 ft, a range of 0.9 ft.

Again, the green and yellow-orange circles are the staff gauge readings. The vertical grid lines are here 2 months apart. The blue dots—which merge into a continuous line most places—are the actual measurements every hour, 24/7, winter and summer. In winter the pressure loggers include the weight of the ice and snow so are water-equivalents because a kilogram of ice is the same weight as a kilogram of water. The solid gold dot ● at 6/10/14 and 899.705 feet is the AECOM measurement on that day corrected to [Our Scale](#). See Fig. 13 for a closeup of the gold dot region. Notice that in the entire 5-year period the lake level stays entirely above the concrete dam. (There was no drought.) Note that the elevation jumps up whenever there is a heavy storm.

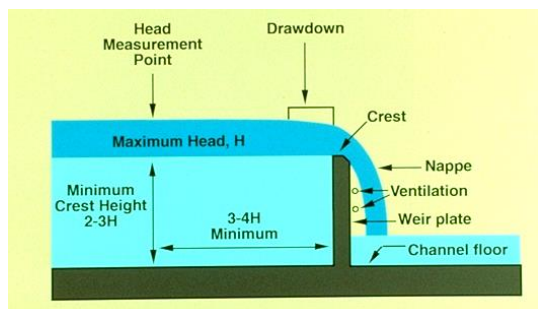
Fig. 9. *Flow pattern over a dam, showing the extra height, called head.*

Note that if a lot of water flows over the dam, the lake level is higher than the spillway. The extra height, called “head”, is required to speed up the flow to get the required cubic feet per second over the spillway. The higher the flow, the higher the head. The wider the dam, the lower the head. For the 9 ft. wide concrete dam at the road, the spring runoff can easily make ½ ft. of head. The spillway height cuts off flow if the lake level falls below the dam. Thick vegetation at the natural dam also raises the head because it takes extra energy to flow through it. From aerial maps, we see that the vegetation has gotten much thicker since 2005 (Fig. 12). Given the flow rate,

we could calculate the head for the concrete dam, but we don't know the shape of natural dam #1533, so we can't calculate the head for it.

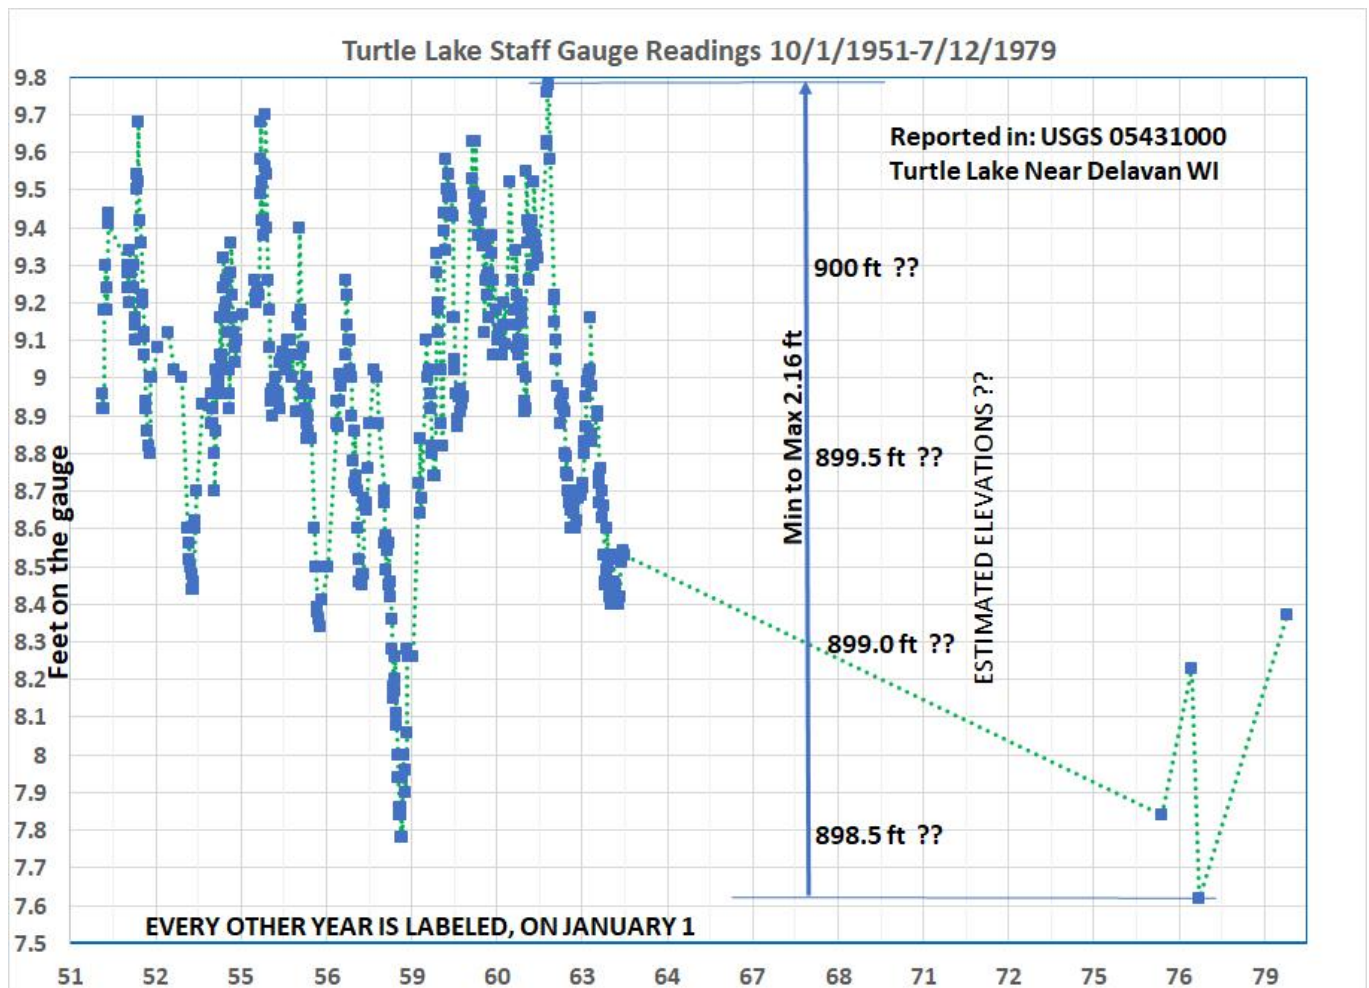
*Fig. 10. USGS elevation changes in Turtle Lake for 28 years (1951-1979).*

Fig. 10. Someone at the lake, directed by the USGS, installed an official ruler (staff gauge) and read the **changes** in lake level from 1951 to 1979 (28 years). The graph shows the readings from the staff gauge as blue squares, connected by a green dotted line to aid the eye. The local USGS office still has the file for these measurements. The reader(s) measured about once a week then quit after 1963 but came back to it when the lake again painfully dropped again in 1975. **The range high to low was 2.16 feet**, the same as our data in the last 10 years. The lake and the weather seem similar in different decades: A few very-highs and a few very lows. The official markers with sea level elevations were not installed until 1965, 6 years after they quit.

I added a guess for the sea level elevation scale—with double question marks. What sea level elevations would **you** put there? Why did I guess that particular elevation scale? How **uncertain** do you think my guess is—0.1 ft, 0.2 ft, 0.3 ft?

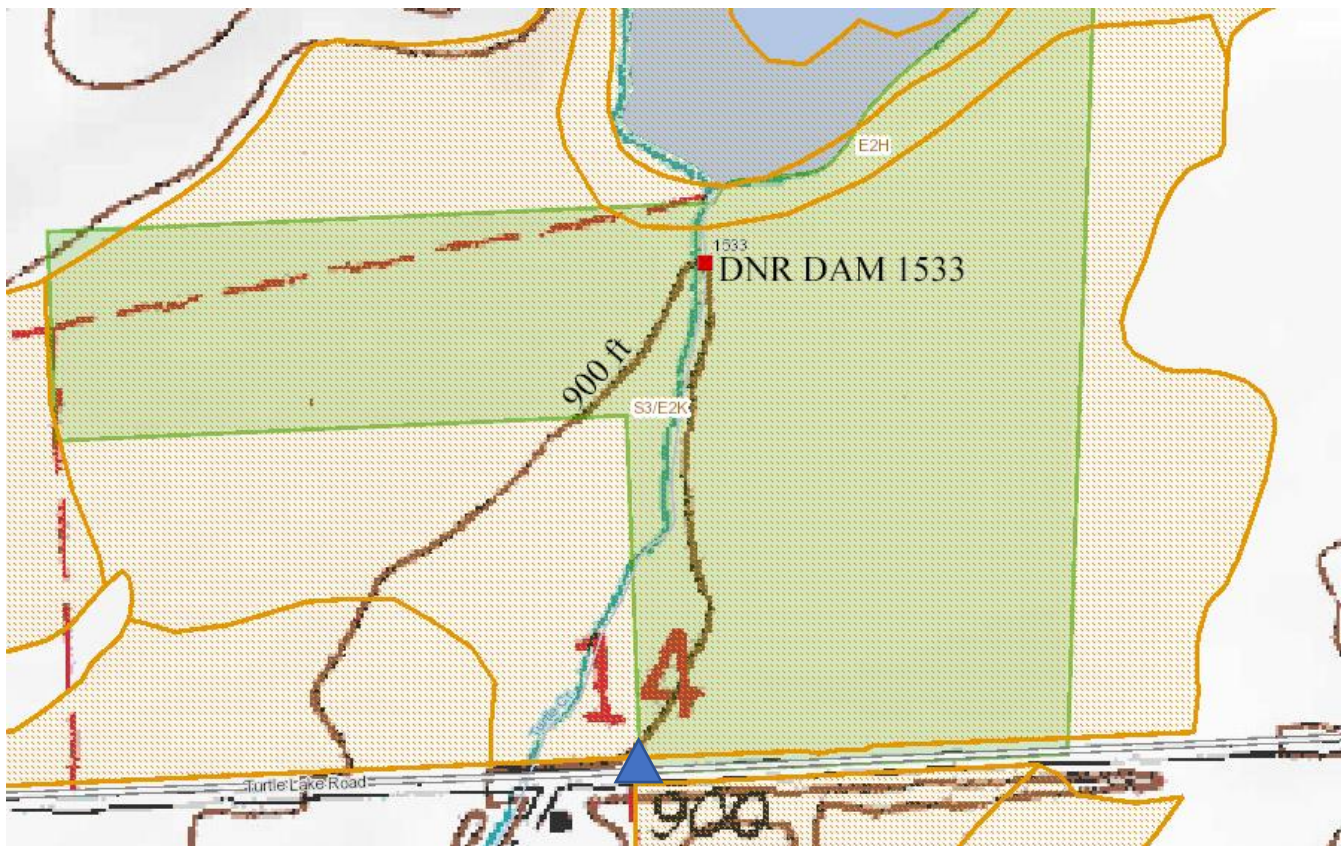
↑Fig. 11 WDNR Map locating WDNR dam #1533 (As of June 2019).

Green shading shows public (WDNR) land; orange shows mapped wetlands. (The survey marker in the road [blue triangle] locates one edge of the WDNR land.) The official dam (red square) lies on the **900 ft contour** & the mapped creek (thin blue line). It is just south of the westerly bend in the creek and south of the permanent marsh (E2H). The breach is not yet shown in this map. You can exercise the **layers** of this map [online](#).

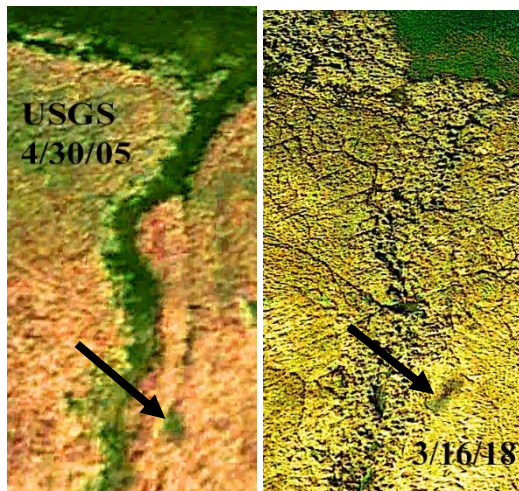
*Fig. 12. 2005 & 2018 Closeups: note bush & the arrow crossing the creek.*

*Dam #1533 may be at the arrow crossing. Note the growth of vegetation in the channel and shore since 2005. The channel is again filling in. Aerial photos from 2005 and 2018 show a “permanent” bush or tree within about 30 feet of this dam, indicating high ground. After about 2011, it became impossible to take a boat to dam #1533 because of increased vegetation in the channel. Perhaps walking in from east or west keeping south of the permanent marsh*

*would be possible, especially in winter or very early spring.*

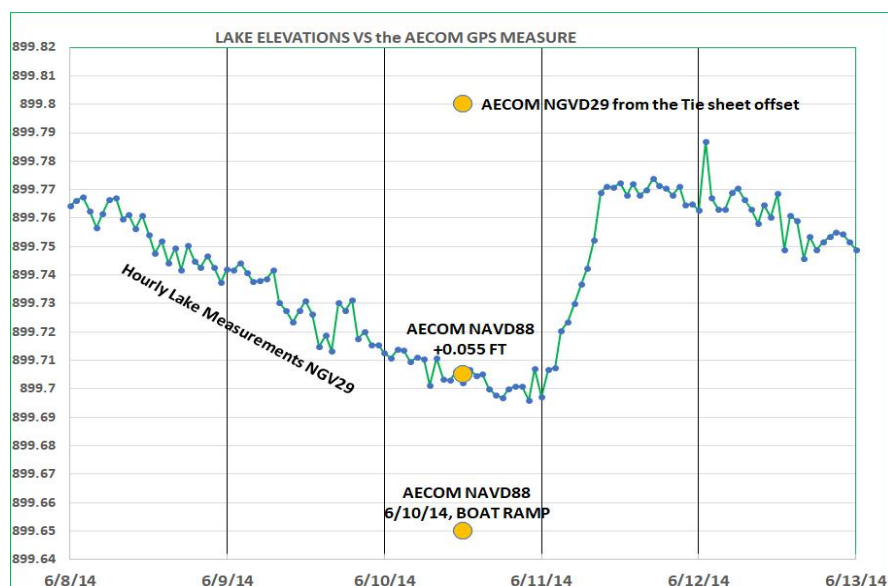
←Fig. 13. The correction applied to the 6/10/14 AECOM NAVD88 measurement to match our lake levels is + 0.055 ft. (Vertical steps are 0.01 ft. We've zoomed in 365 times horizontally, and 10 times vertically.)

This correction is used above to help establish the elevation of the concrete dam to our datum. Gold dots show the AECOM measurements—and

with 2 different corrections.
